**Doctors Residence  
38 Laverendrye Crescent  
Marathon Ontario**

**Moisture Penetration Report**

Submitted: September 20, 2023

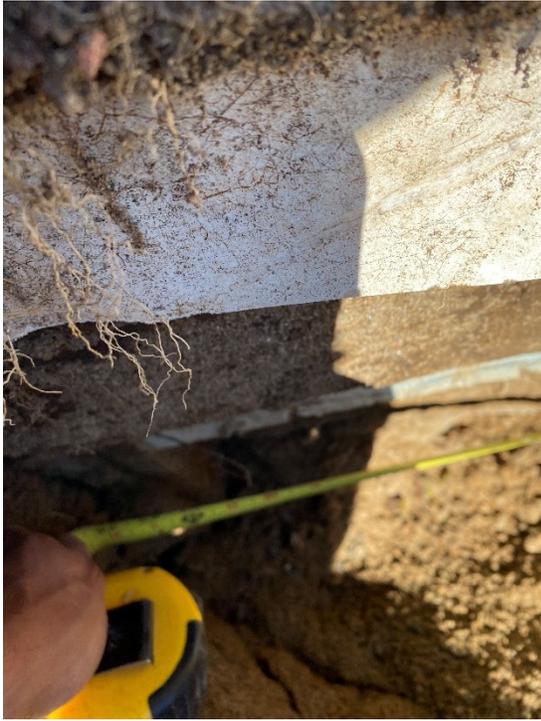
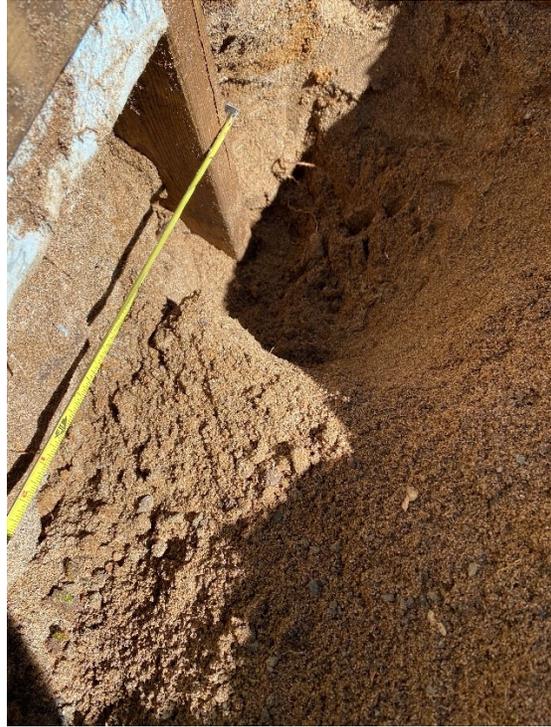
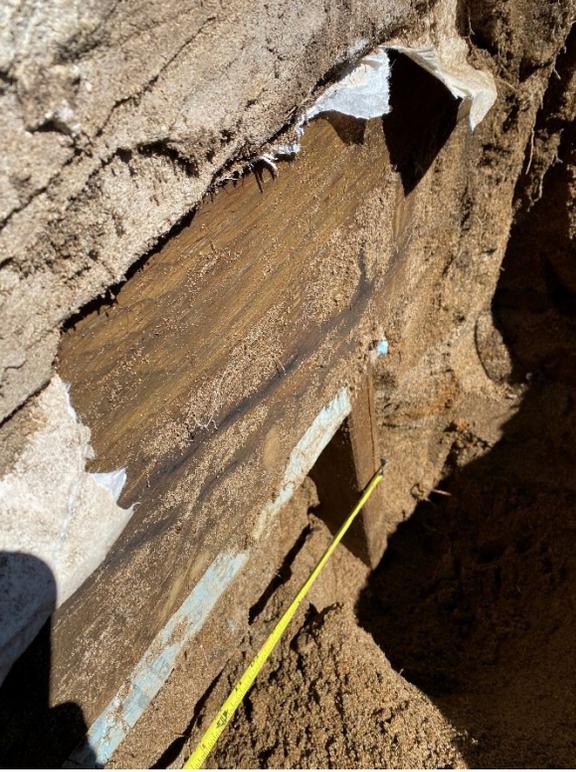
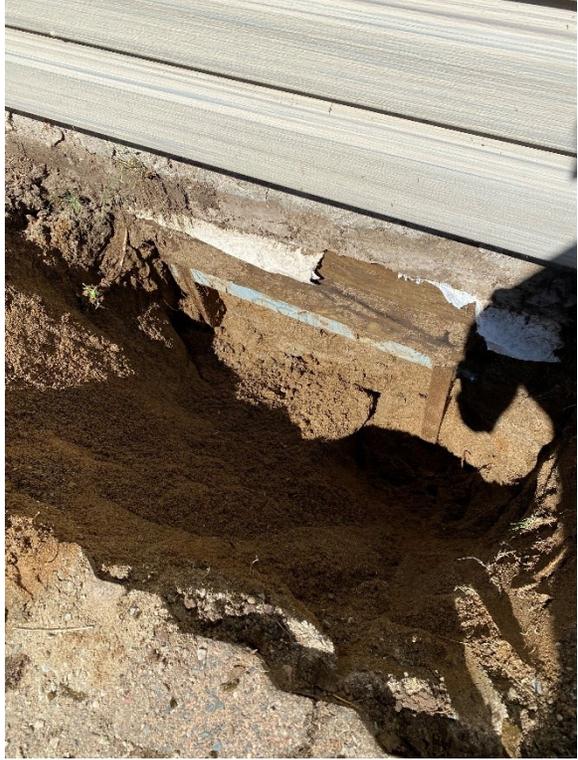
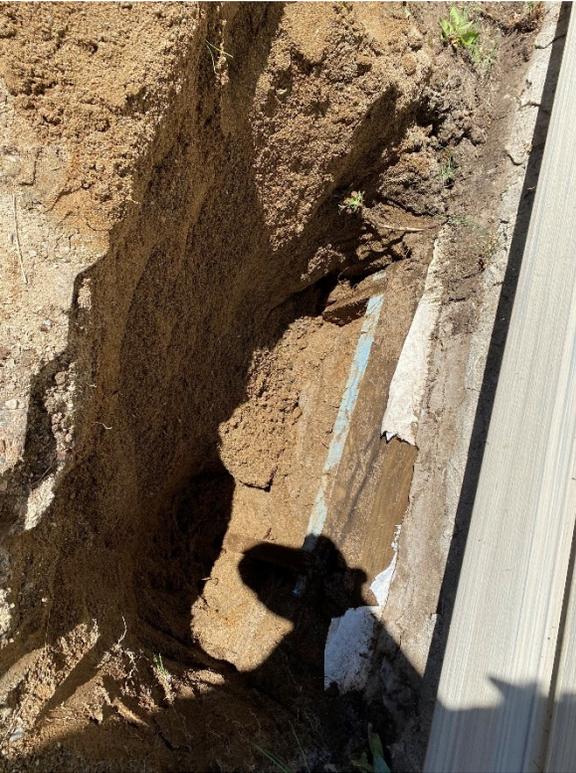
Foundation Walls: Approximately 30 feet of the top of the pressure treated foundation walls along the back and right side of the residence was opened up on the inside of the building from the concrete floor slab to the underside of the floor joist above.

- The sill plates at the concrete floor slab in various locations are rotted out along with the bottoms of the wood studs.
- It is noted that the wood plates have a damp sand back fill below the wood plates.

Exterior Wall Foundation Wall below grade: The municipality exposed the exterior side of the foundation walls.

- The foundation wall is constructed with evenly spaced wood studs.
- The exterior grade slopes towards the house directing water to the foundation wall.
- The exterior sheathing appears to extend to a depth of approximately 16" and in various locations is rotted.
- The wood studding also appears to not be protected. There is sand and gravel backfill material between the wood studs of the foundation walls.
- All the above are non-compliant building code issues.

Foundation Wall Remediation:

- Temporary support upper floor, roof, and wall framing.
- Cut back existing interior concrete floor slab.

- Remove damaged foundation construction as required.
- Provide new concrete footings, block masonry or concrete foundation wall, and perimeter building insulation.
- Provide weeping tile where require.
- Backfill exterior of building and slope grade away from building.
- Backfill interior of building and pour new concrete floor slabs as required.

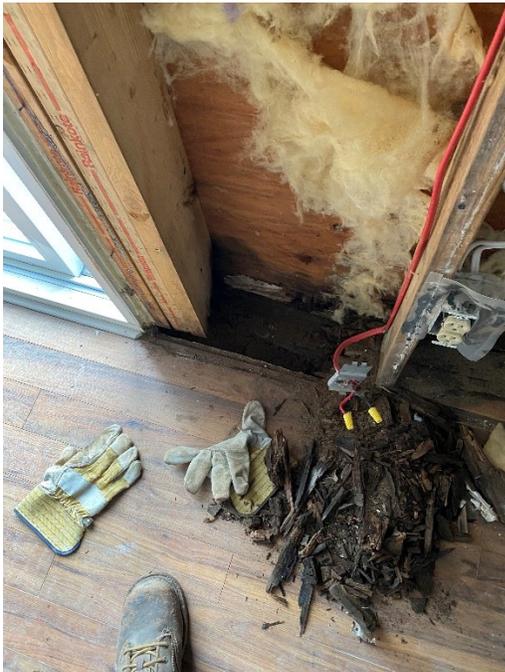
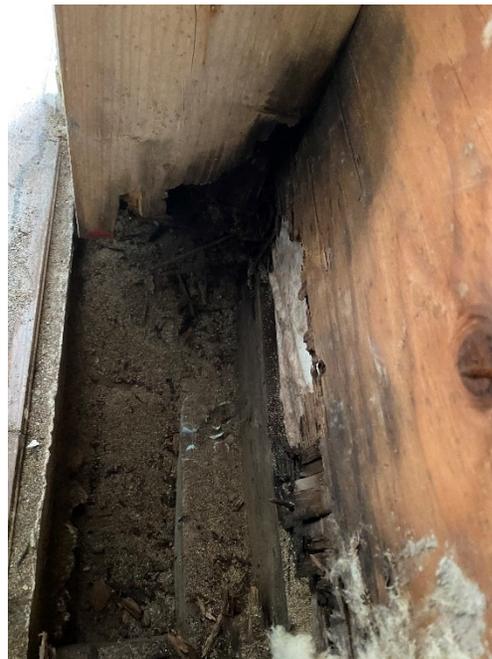
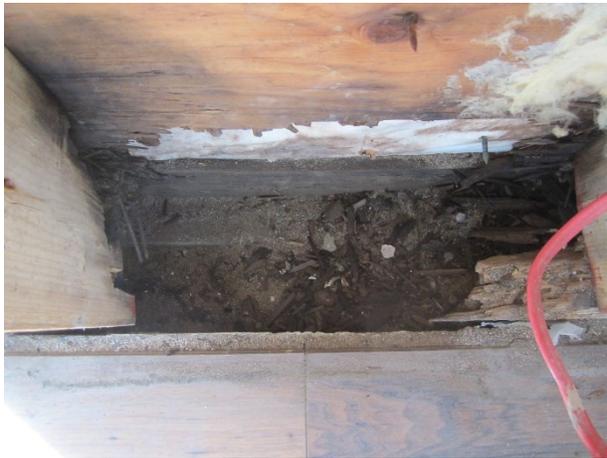
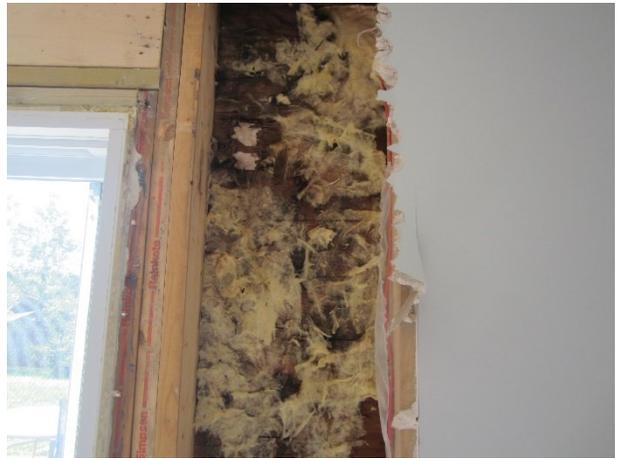
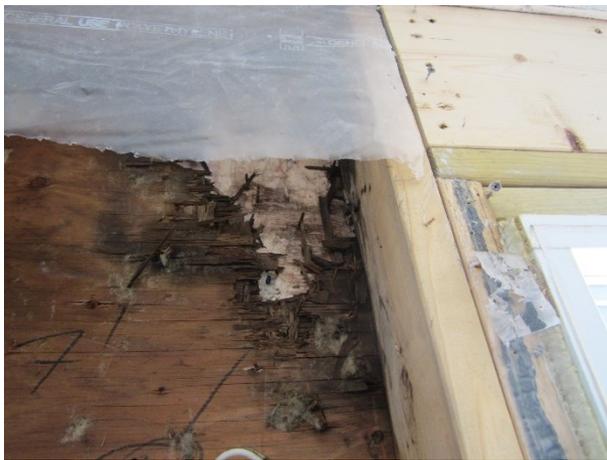
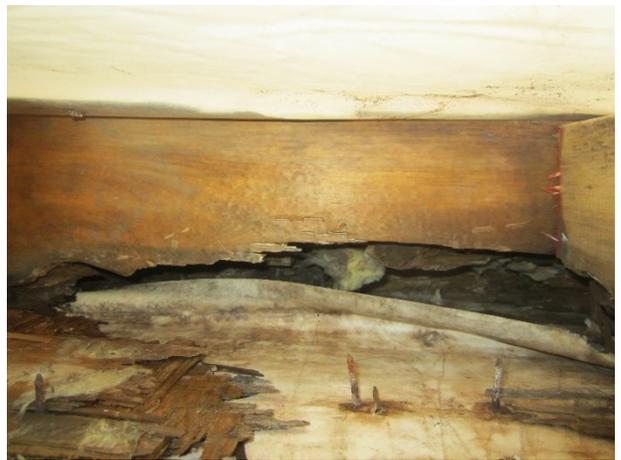
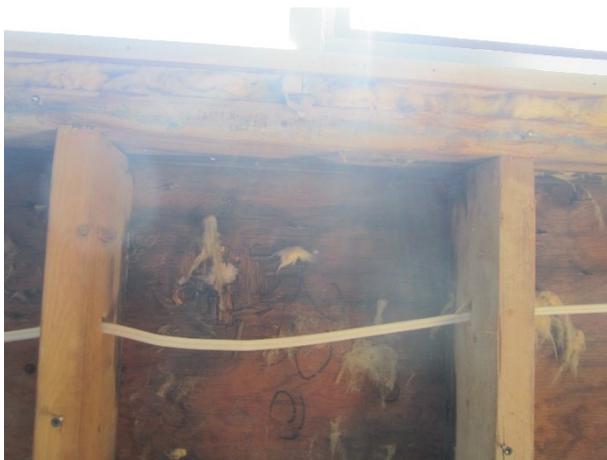
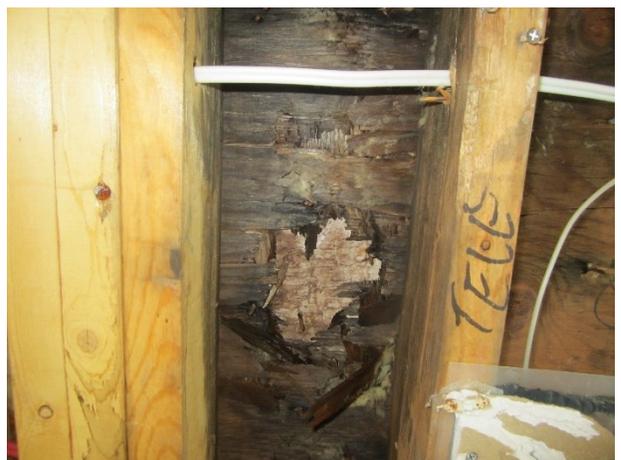
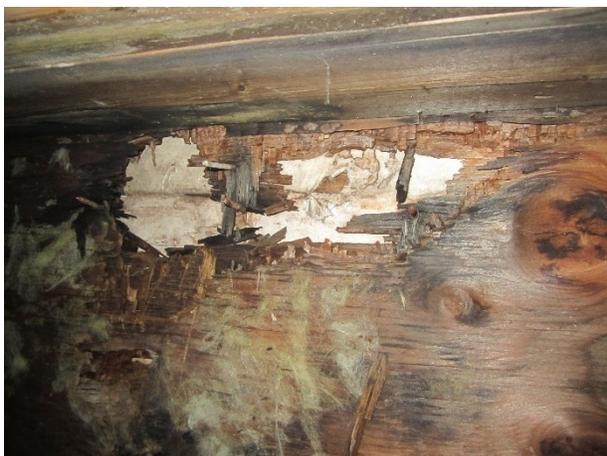
Upper Exterior Walls: The upper exterior wall was exposed from the interior side and the following conditions were found:

- The Insulation was removed to expose the wood stud framing. There was evidence of areas of rotting, water penetration staining, and in some areas mould was present.
- There are areas of the exterior plywood sheathing rotting.
- It was observed that the exterior window aluminium sill cladding on the wood frames is open and allowing moisture to enter the windowsill and possibly into the wall structure.
- The upper walls are vinyl siding over a damaged stucco wall finish. The vinyl siding seems to be contributing to moisture penetration in the wall structure.

Upper Wall Remediation:

- Remove exterior vinyl siding in all locations.
- Remove exterior stucco finish in all locations.
- Examine and remove all damaged wall sheathing.
- Remove all rotten wood studs and replace with new wood studs.
- Remove all areas of mould.
- Remove and replace all windows.
- Replace all wall insulation and vapour barrier.
- Replace all interior wall finishes, baseboards, window trims, and paint as required.
